# **Fundamentals for Remote Structural Health Monitoring of Wind Turbine Blades – a Preproject**

## **Annex E – Full-Scale Test of Wind Turbine Blade, Using Sensors and NDT**

**Ole J.D. Kristensen, Malcolm McGugan, Peter Sendrup,  
Jørgen Rheinländer, Jens Rusborg, Anders M. Hansen,  
Christian P. Debel and Bent F. Sørensen**

**Abstract** A 19.1 metre wind turbine blade was subjected to static tests. The purpose of the test series was to verify the abilities of different types of sensors to detect damage in wind turbine blades.

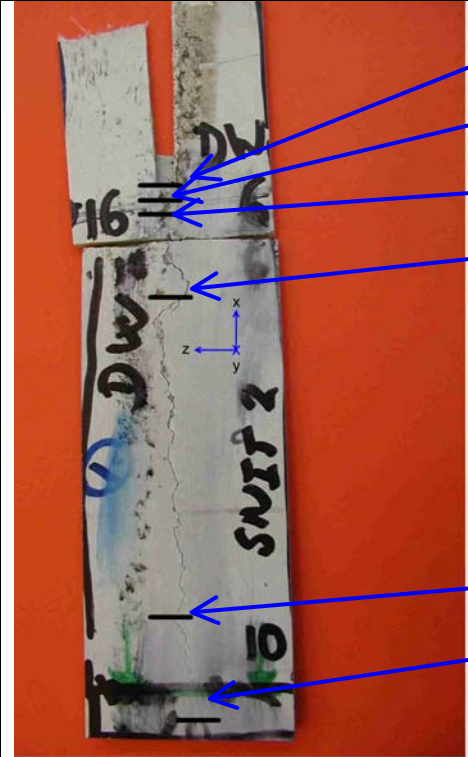
<div>start &amp; WING001</div> <div>WING003</div> <div>WING004</div> <div>WING005</div> <div>WING006</div> <div>WING008</div>	
<p>Figure 19. Crack-like damage in the external surface of the upwind laminate.</p>		<p>Figure 20. Diffuse damage in the internal surface of the upwind laminat (dashed arrows indicate estimated damage front positions).</p>

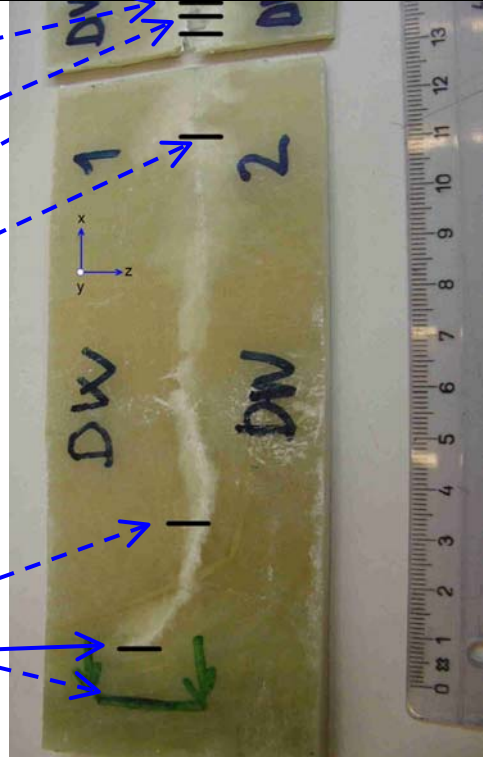
<p>Figure 21. Crack-like damage in the external surface of the downwind laminate.</p>		<p>Figure 22. Diffuse damage in the internal surface of the downwind laminate (dashed arrows indicate estimated damage front positions).</p>

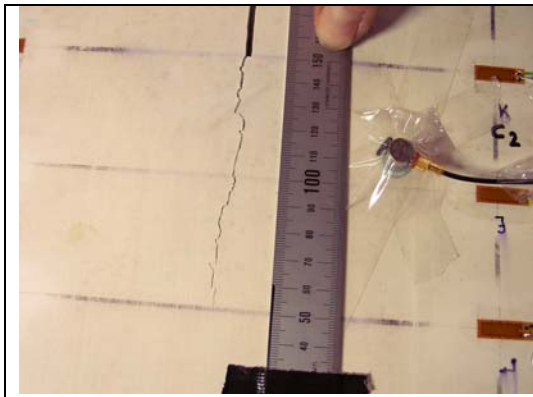
Figure 29. Up-wind damage after WING005  
(note AE sensor , right side)

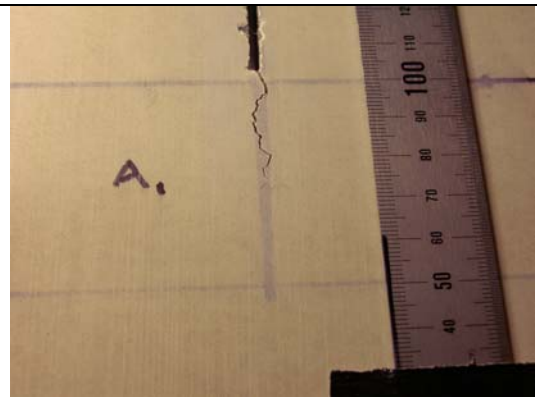
Figure 30. Down-wind damage after WING005

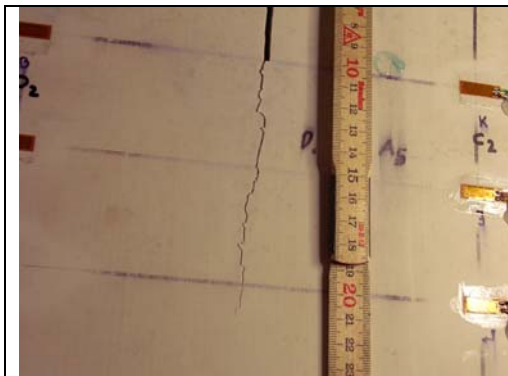
Figure 31. Up-wind damage after WING006

The major difference between WING005 and WING006 is the duration of the crack propagation. During WING 005 the crack propagated over a little less than 10 minutes, and during WING 006 the same size of damage propagation happened within the same minute. This is seen as a very steep change/decrease in the strain level for strain gauge no. 08 at the end of WING 006. Note, that the decrease in strain level appears prior to the unloading/decrease in load level.

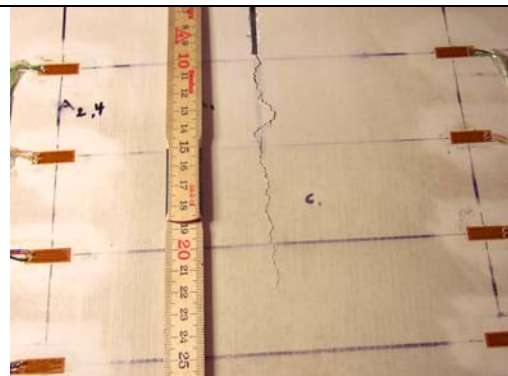
Figure 32. Down-wind damage after WING006

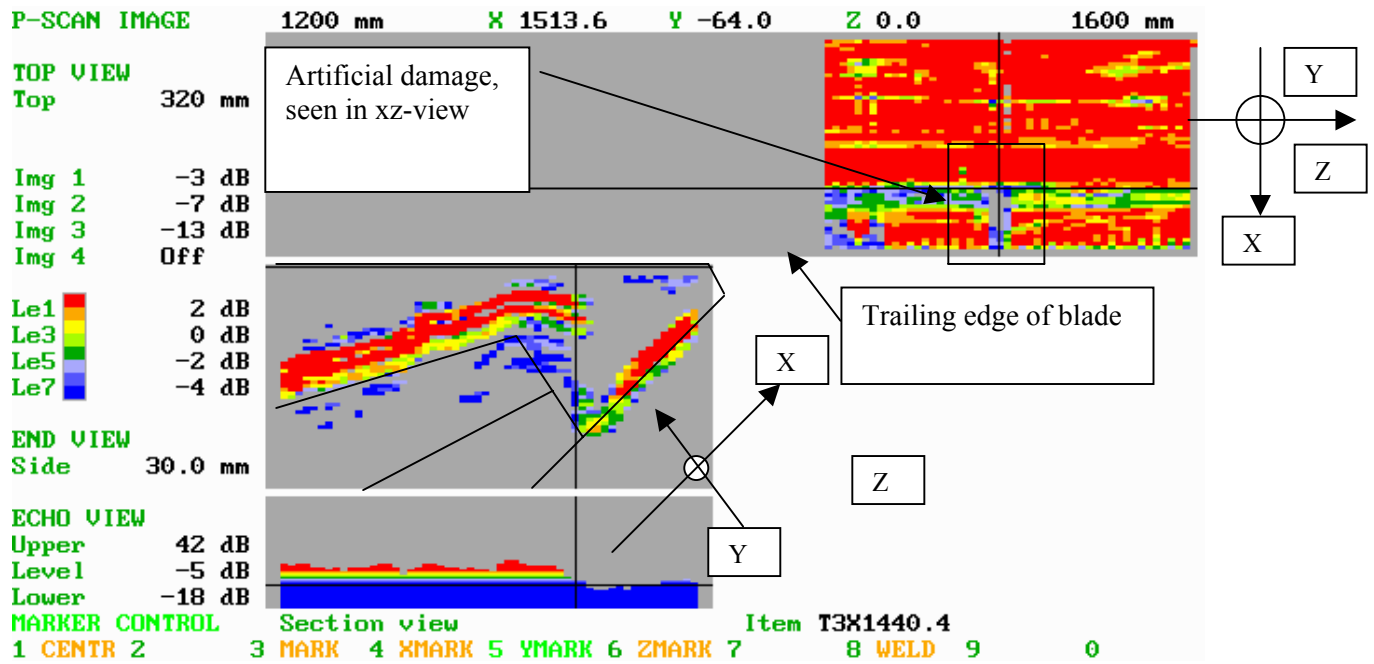
Figure 44. Image showing the result of the ultra sonic inspection of the up-wind surface of the blade after WING 001.

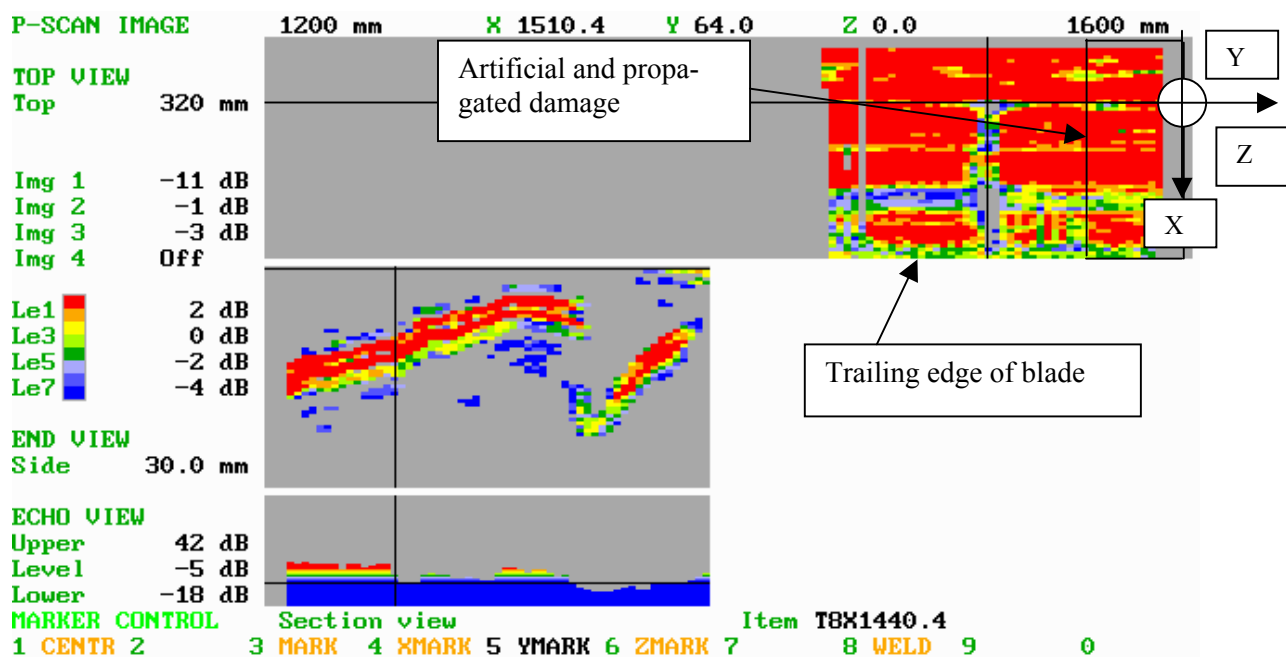
Figure 46. Image showing the result of the ultra sonic inspection of the up-wind surface of the blade after WING 008.

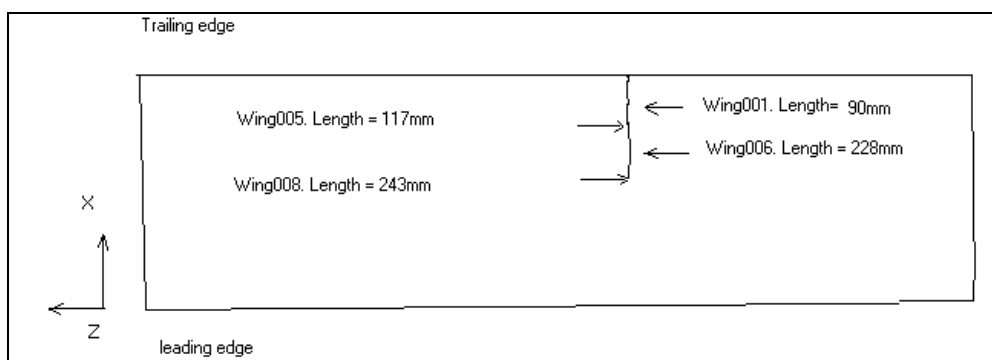
Figure 47. Sketch of propagated damage on down-wind surface after WING008, based on ultrasonic inspections

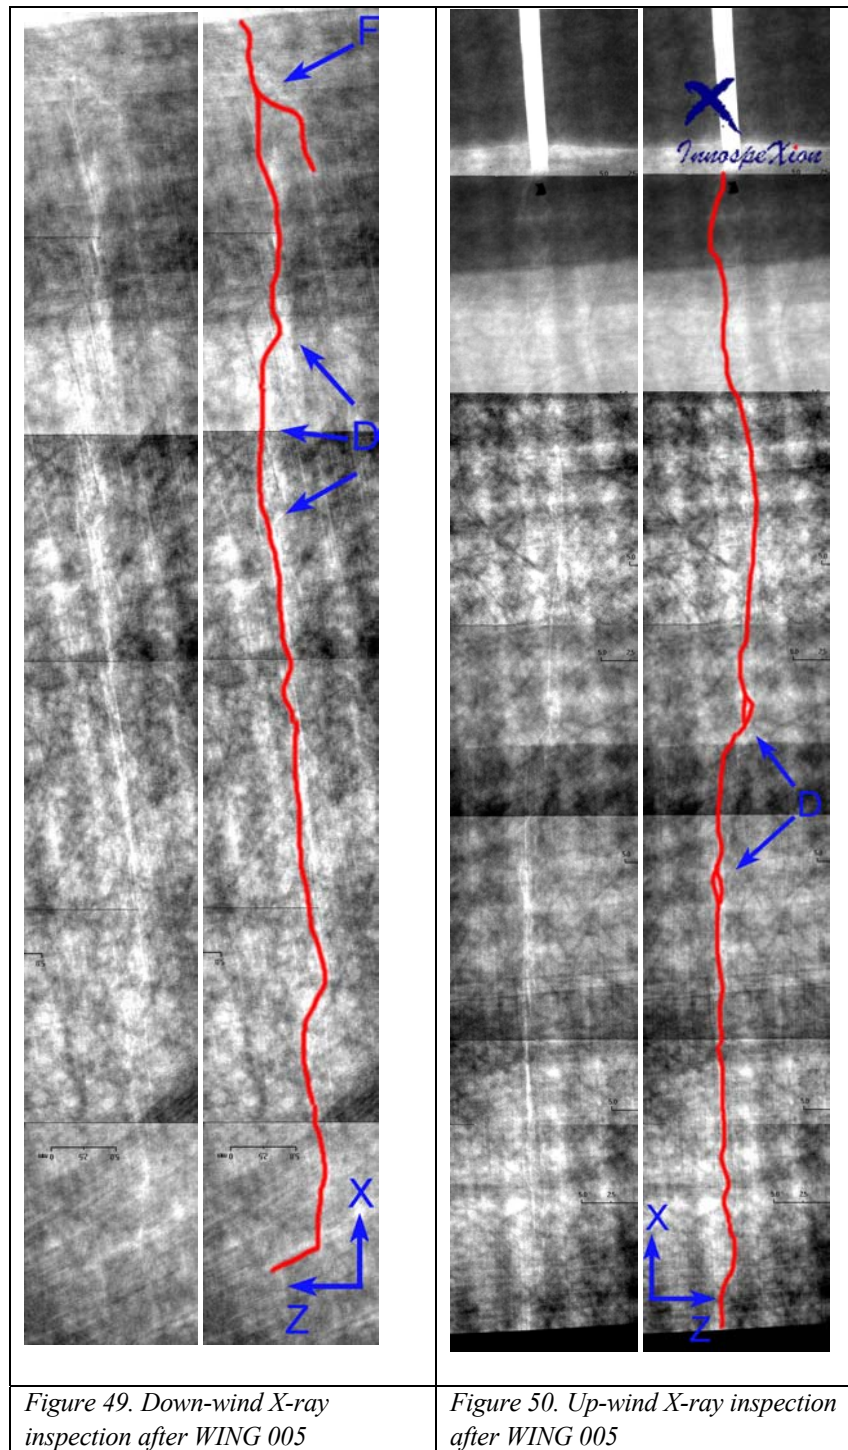
Figure 50 shows the X-ray image of the up-wind surface of the blade. Note how the crack follows the fibre orientation. The crack ends abruptly upon meeting an area of the blade with a sharp increase in thickness. The letter "D" indicates an area where crack is diffusely defined, multiple cracks run through these two areas.

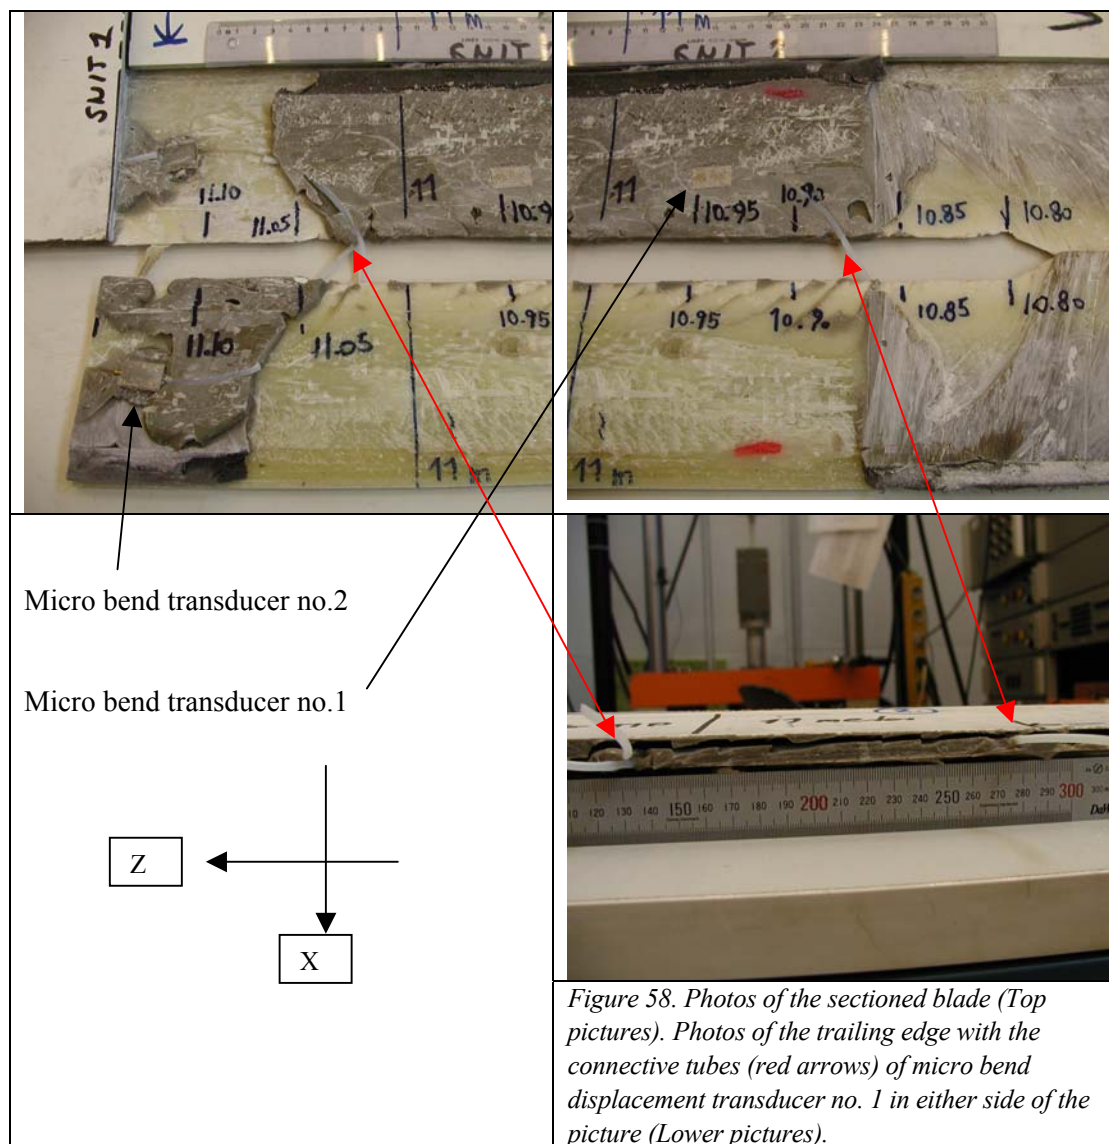
On these pictures it appears as the damage is propagating in an angel of 30° to 45° relative to the trailing edge and with direction towards the tip. This corresponds very well to the ultrasonic inspections as described in paragraph 6.5.

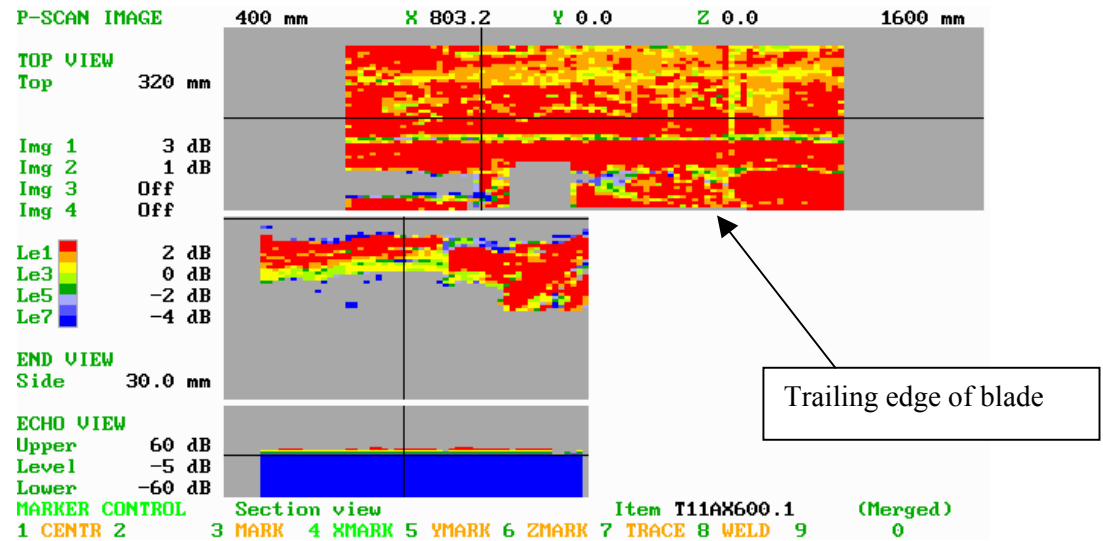
Figure 68. Image showing the result of the ultra sonic inspection of the up-wind surface of the blade after WING 118.

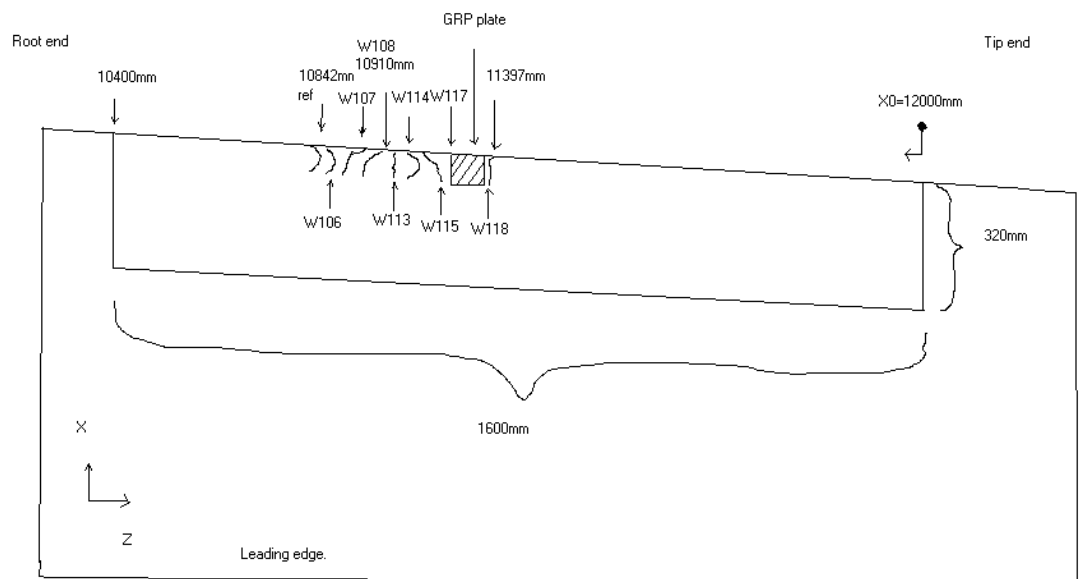
Figure 69. Sketch of damage propagation based on the ultrasonic inspections
